UNIVERSITY
of DAYTON
RESEARCH
INSTITUTE

NAVY HIGH-STRENGTH STEEL CORROSION-FATIGUE MODELING PROGRAM

October 2006

1. REPORT DATE OCT 2006		2. REPORT TYPE Technical Report		3. DATES COVERED 30-06-2003 to 31-08-2006	
4. TITLE AND SUBTITLE Navy High-Strength Steel Corrosion-Fatigue Modeling Program			5a. CONTRACT NUMBER F42620-00-D-0039, 0011		
			5b. GRANT NUMBER		
			5c. PROGRAM ELEMENT NUMBER

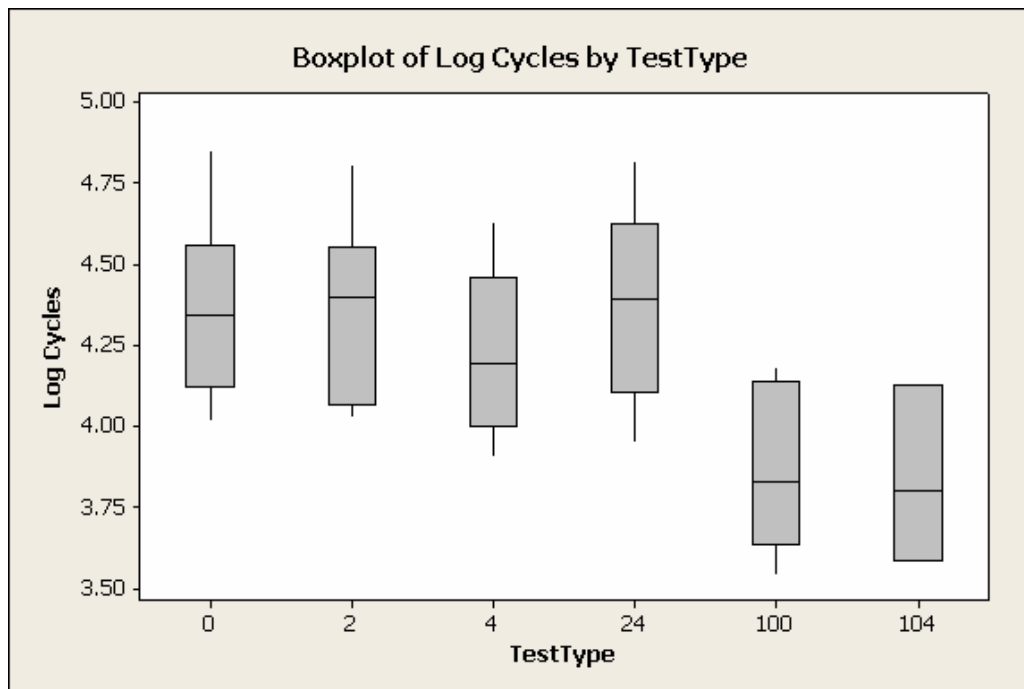
Figure 3.1-1. Boxplot of Fatigue Life and the Test Type Correlating to the Number of Hours of Exposure to the Corrosive Agents

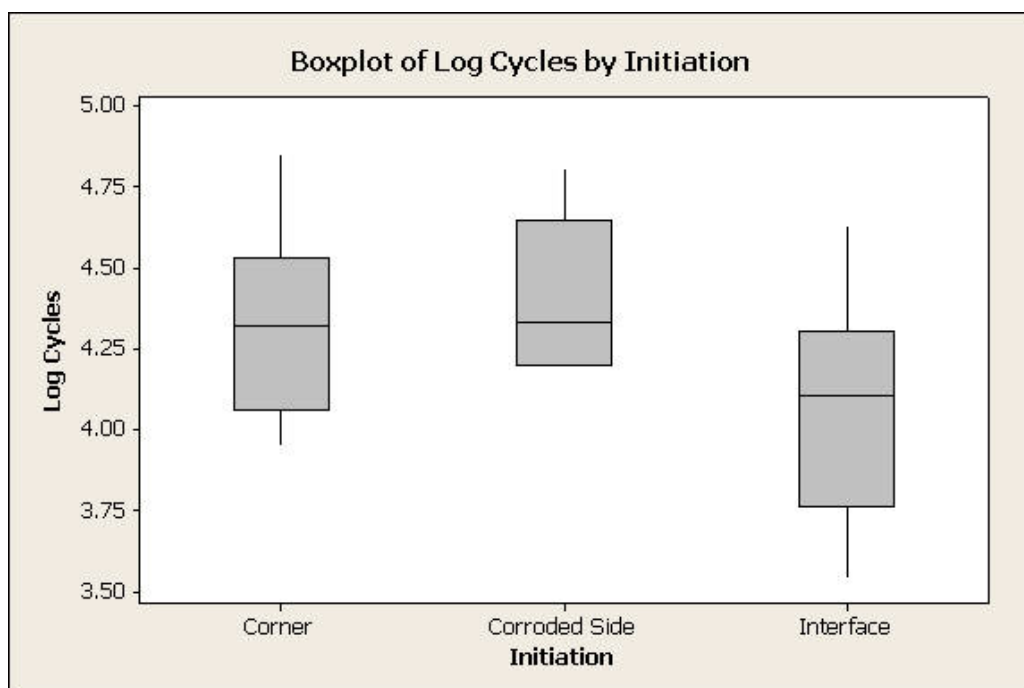
Figure 3.1-2. Boxplot of the Fatigue Life and the Crack Initiation Location

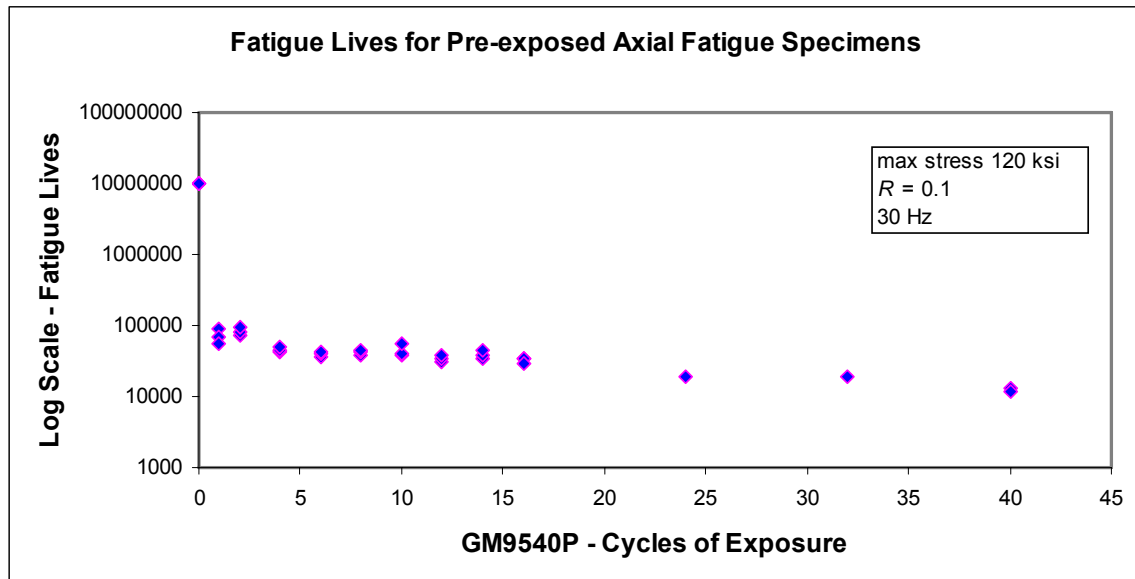
Figure 3.2-2. Fatigue-Life Curve for Pre-Corroded Axial Fatigue Specimens

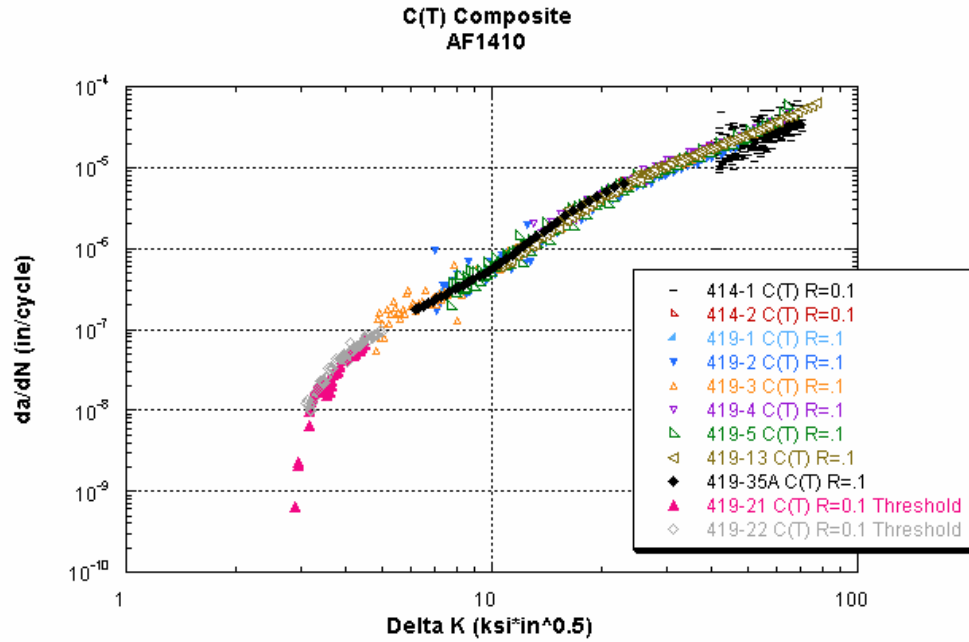
Figure 4.1.7-3. Fatigue Crack Growth Rate Tests for AF1410 Steel in Ambient Laboratory Air with a Load Ratio of 0.1 Using C(T) Specimens

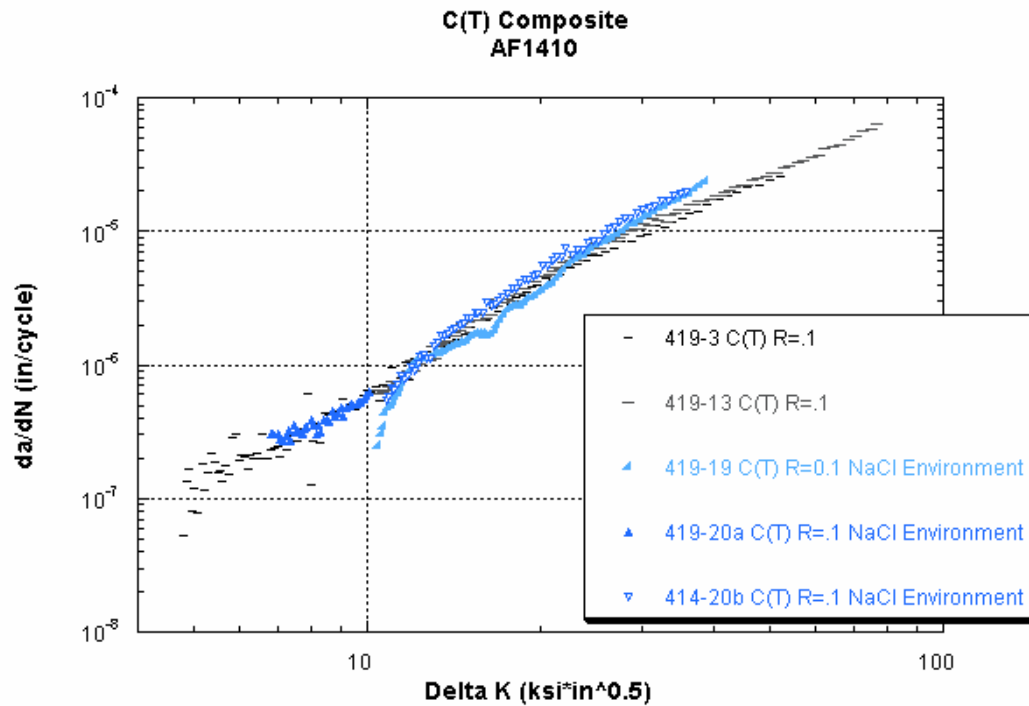
Figure 4.1.7-5. Fatigue Crack Growth Rate Tests for AF1410 Steel in Ambient Laboratory Air or in a High-Humidity and NaCl Environment with a Load Ratio of 0.1 Using C(T) Specimens

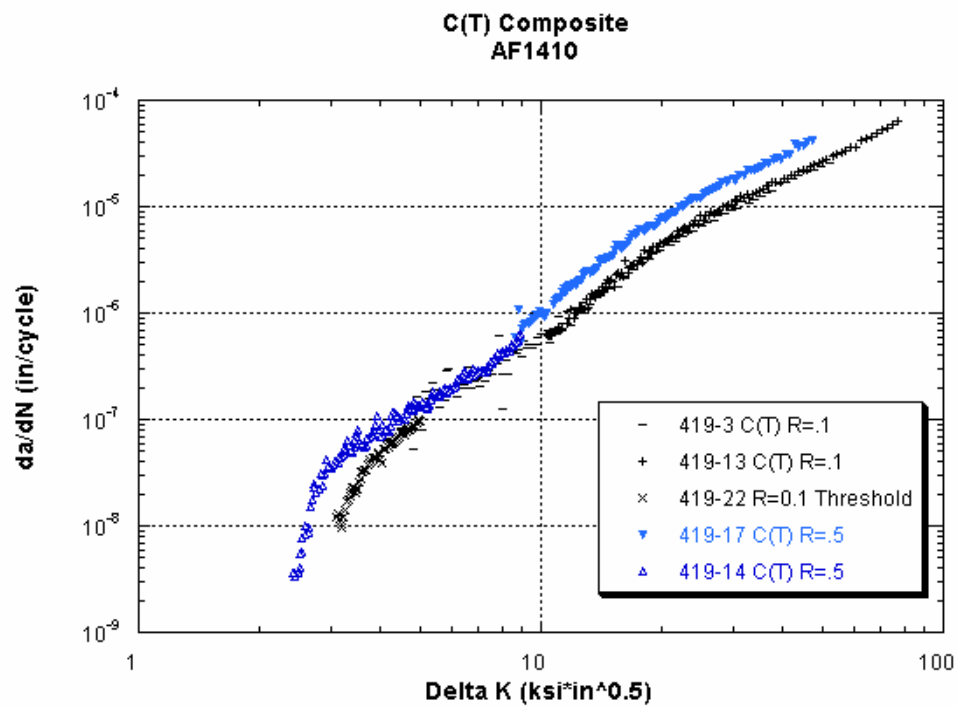
Figure 4.1.7-6. Fatigue Crack Growth Rate Tests for AF1410 Steel in Ambient Laboratory Air Comparing Load Ratios of 0.1 and 0.5 Using C(T) Specimens

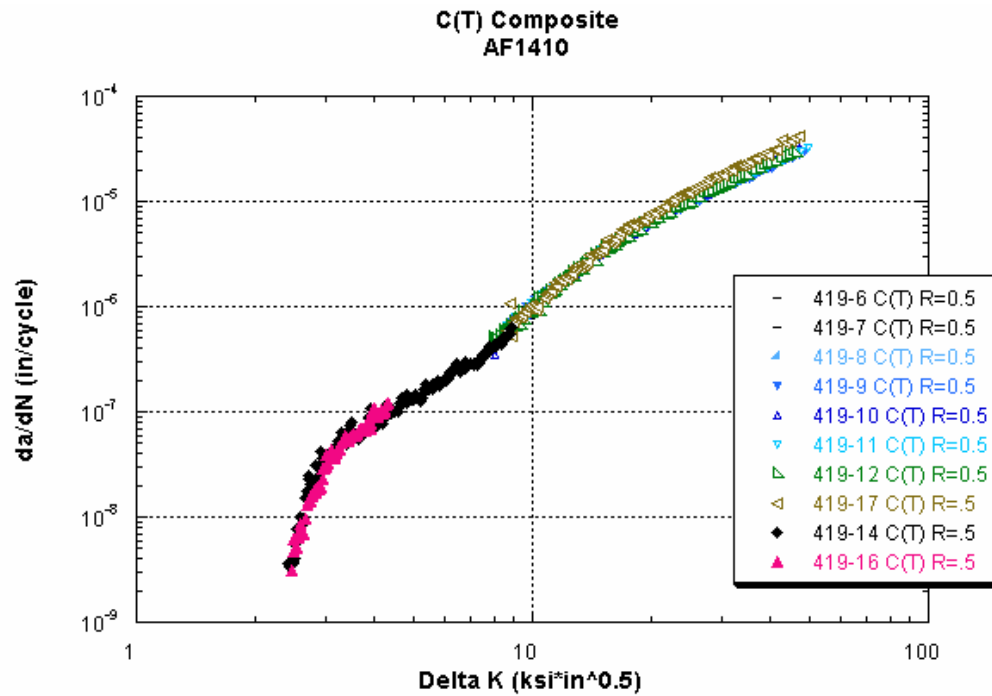
Figure 4.1.7-7. Fatigue Crack Growth Rate Tests for AF1410 Steel in Ambient Laboratory Air with a Load Ratio of 0.5 Using C(T) Specimens

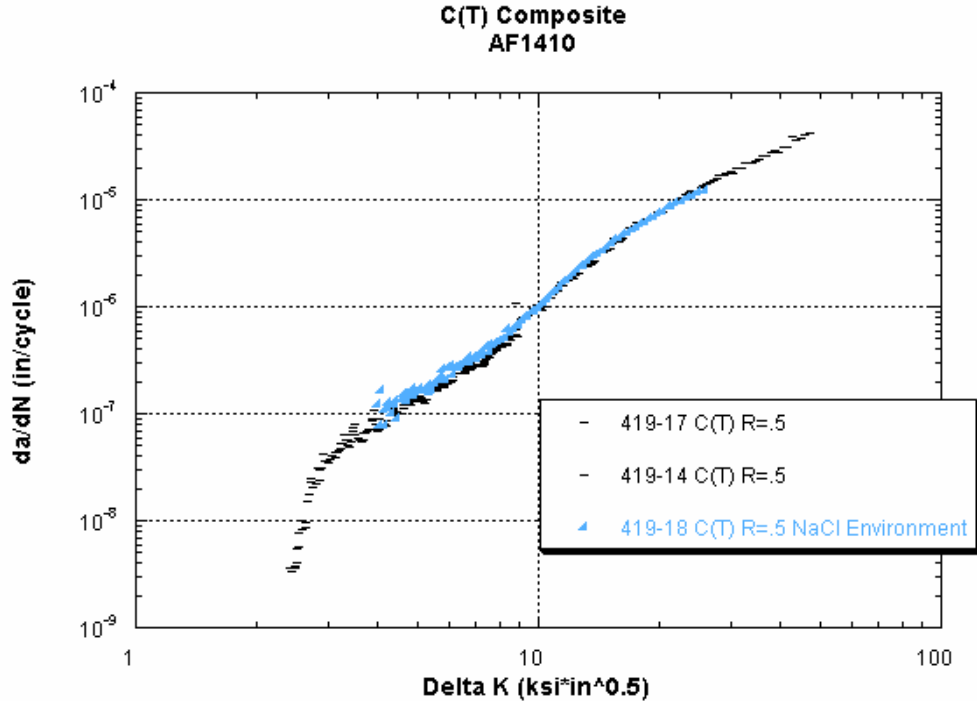
Figure 4.1.7-8. Fatigue Crack Growth Rate Tests for AF1410 Steel in Ambient Laboratory Air or in a High-Humidity and NaCl Environment with a Load Ratio of 0.5 Using C(T) Specimens

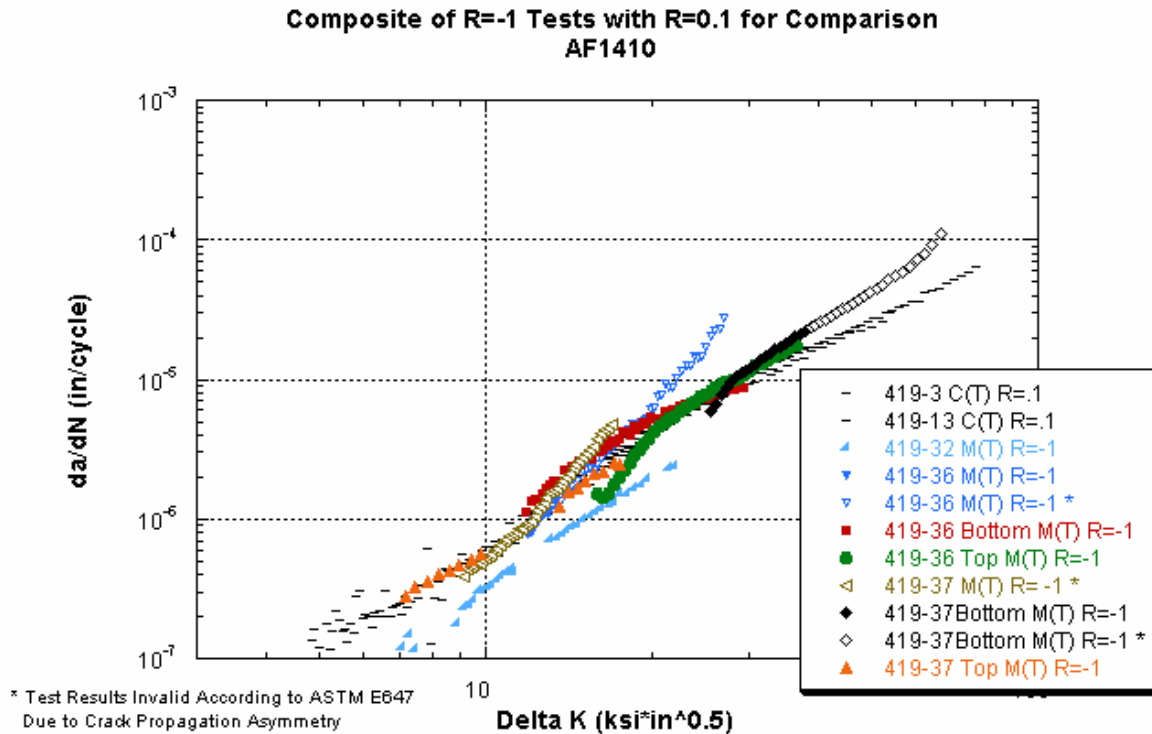
Figure 4.1.7-9. Fatigue Crack Growth Rate Tests for AF1410 Steel in Ambient Laboratory Air Comparing Load Ratios of 0.1 and -1 Using C(T) and M(T) Specimens

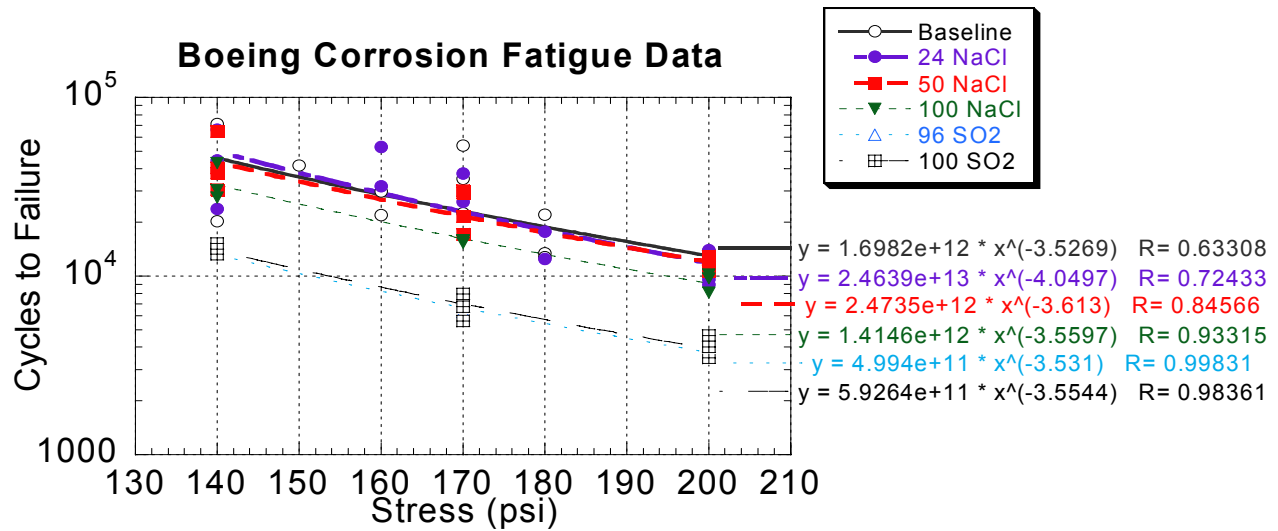
Figure 4.2.1-2. Boeing Corrosion Fatigue Data, Cycles vs. Stress

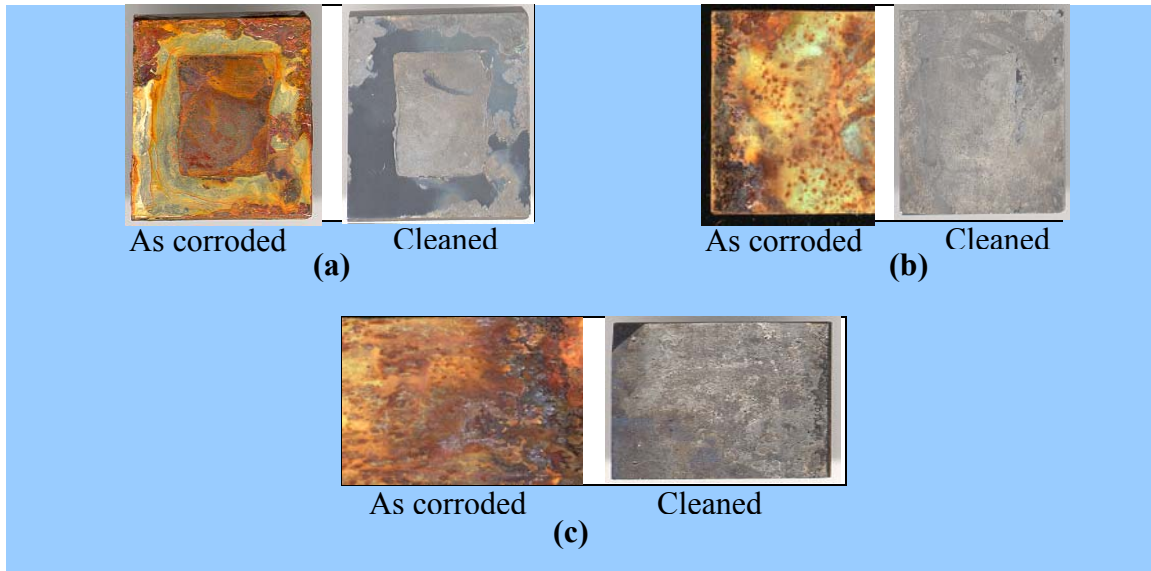
Figure 4.2.1-12. Alternate Immersion Specimen Exposed for: (a) 20 days, (b) 40 days, and (c) 60 days (approximate specimen dimensions: 1" □ 1.5")

The alternate immersion test demonstrated that successfully masking an isolated area for alternate immersion exposure is more difficult than for salt fog exposure. The masking failed on each specimen tested by UDRI. Example photographs of specimens after 20, 40, and 60 days of exposure are shown in Figure 4.2.1-12. In the figures, each image on the left shows the respective specimen in the as-corroded condition, and each image on the right shows each respective corroded specimen after it had been cleaned of the oxides. The masking did leave an isolated area on the 20-day exposure sample, but not on the 40- and 60-day exposure samples.

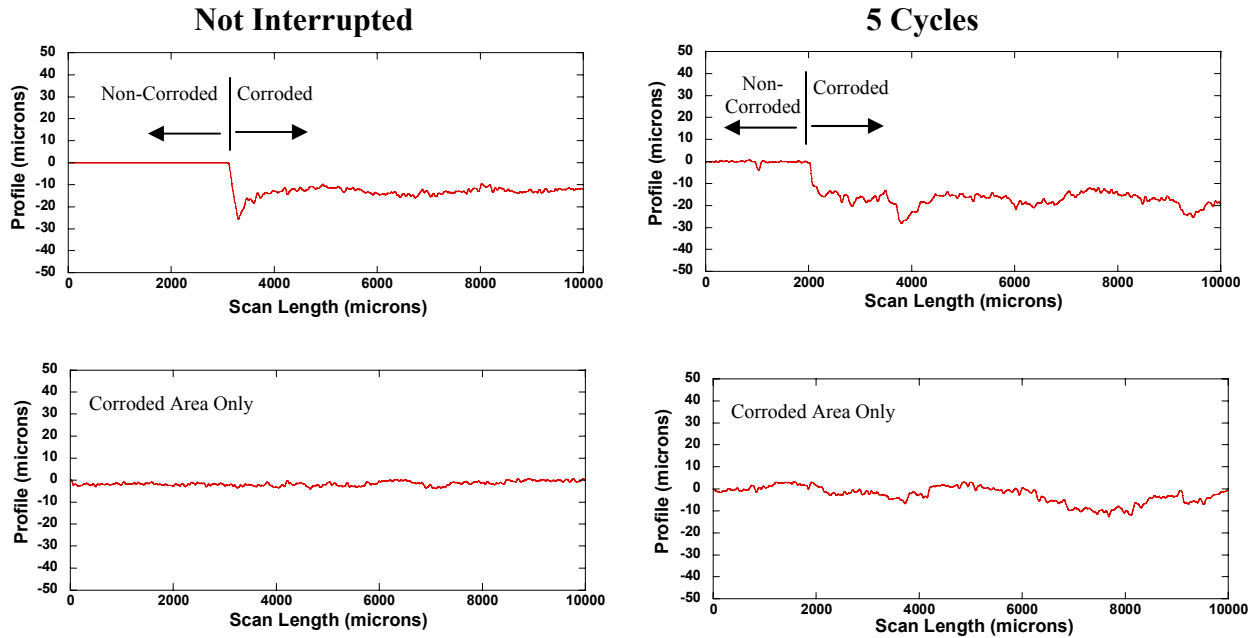
The plots on the left show profile data from a sample exposed without interruptions and the plots on the right show data from a sample whose exposure was interrupted and the filter paper replaced 5 times. The upper plots are from the edge of the corrosion patch and the lower plots are from the center. The exposure that was not interrupted created severe undercutting at the filter paper edge, observable thickness loss, but a fairly smooth corroded surface. The exposure that was interrupted did not show evidence of undercutting, but showed observable thickness loss and a rough surface.

Figure 4.2.1-22. Data Taken on Samples Exposed to 2 mA/cm^2 for a Total of 4 Hours

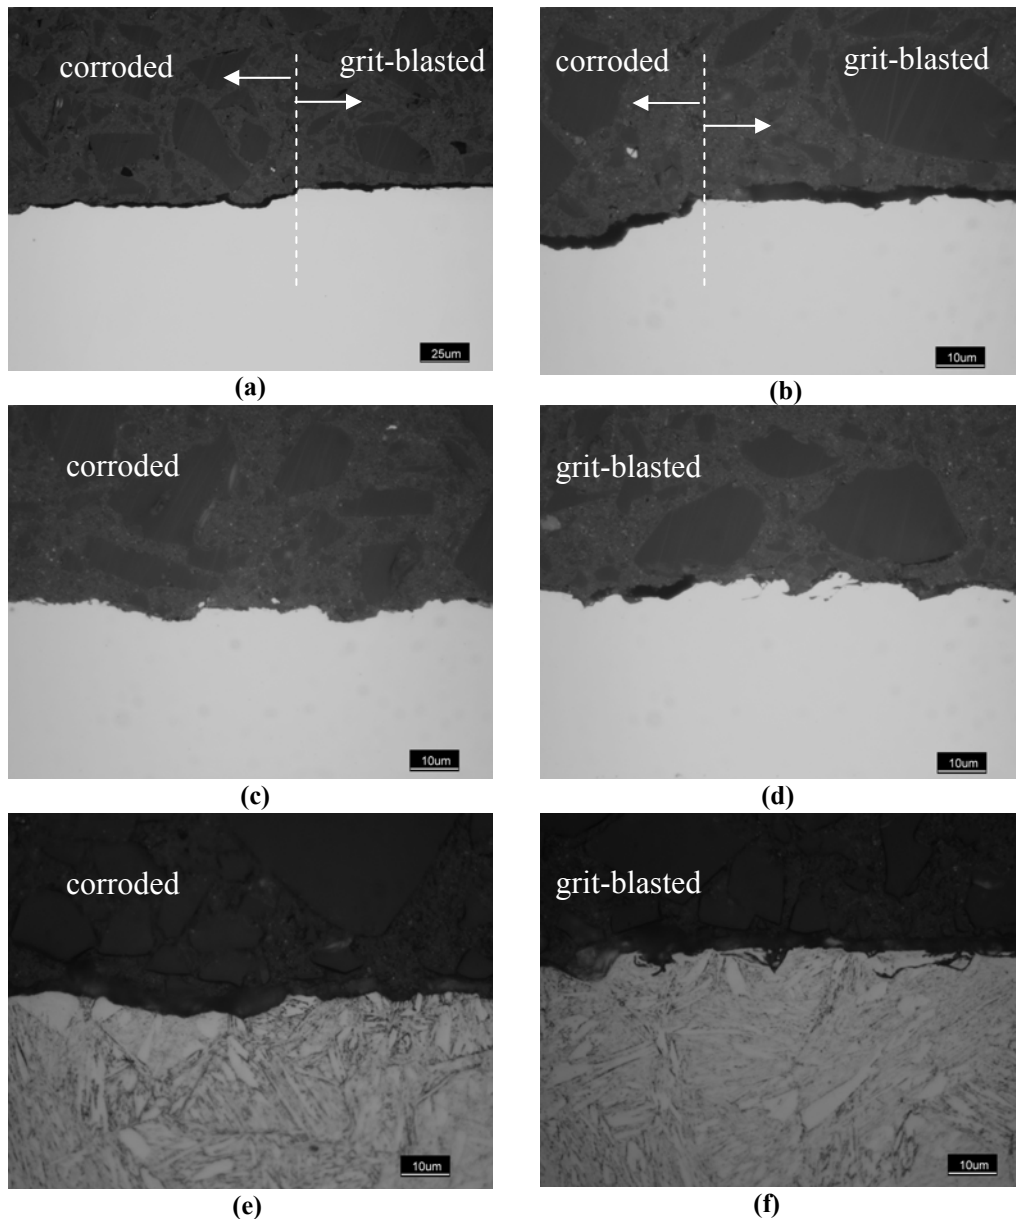
The last two images in Figure 4.2.1-24(e) and (f) are, again, of the corroded region and of the grit-blasted region (non-corroded region), respectively. In this case, the surfaces were etched with 2% Nital for several minutes in order to reveal the martensitic microstructure. Note that these images were not taken in the same locations as the images in Figures 4.2.1-24(c) and (d). It can be observed from these images that the corrosion does not seem to preferentially ingress along grain boundaries. Instead, it has a general corrosion appearance. During optical inspection, it was also observed that the corrosion attack at the surface does follow laths in the microstructure. The ingress observed is very shallow and is limited to a depth just below the surface. This phenomenon is not evident in these figures due to the quality of the sample preparation and of the images.

Figure 4.2.1-24. Cross-Section Images of Test Wafer AF1410-3hrs: (a) & (b) are micrographs of the transition region between the corroded and grit-blasted surfaces, (c) & (e) were taken in the corroded region, (d) & (f) were taken in the grit-blasted region. The images in (e) and (f) were taken after the cross-sections were etched in 2% Nital.

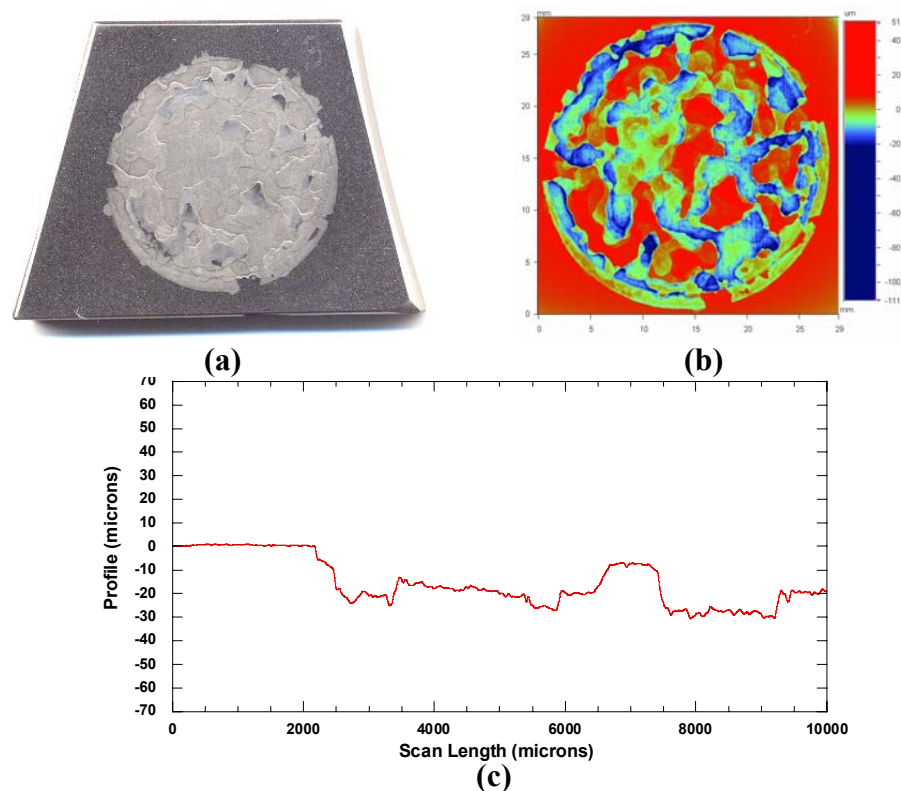
The corroded surface of the specimen was then inspected using both a mechanical stylus and a white-light interferometer. The height map generated by the WLI microscope for test wafer AF1410-6hr is shown in Figure 4.2.1-25(b). An example line profile of the transition between the non-corroded and corroded surface was taken at approximately the 12 o'clock position with a stylus and is shown in Figure 4.2.1-25(c). The statistical analysis for the data is shown in Table 4.2.1-6. The data show that there is an increased level of corrosion in terms of statistical metrics that are based on average roughness or volume loss with the increased time of exposure. It was found that this specimen's non-corroded, but grit-blasted surface is less rough than was targeted by the grit blasting. The Ra, which is less than 0.3, is well below the target range of 1 to 1.5.

Figure 4.2.1-25. Test Wafer AF1410-6hr: (a) photograph of the corroded surface after the 6-hour exposure (the diameter of the corrosion patch is approximately 1.0625"), (b) height map of the corroded surface as measured using the white-light interferometer, and (c) line profile of the transition between the non-corroded and corroded surface taken at approximately the 12 o'clock position with a stylus.

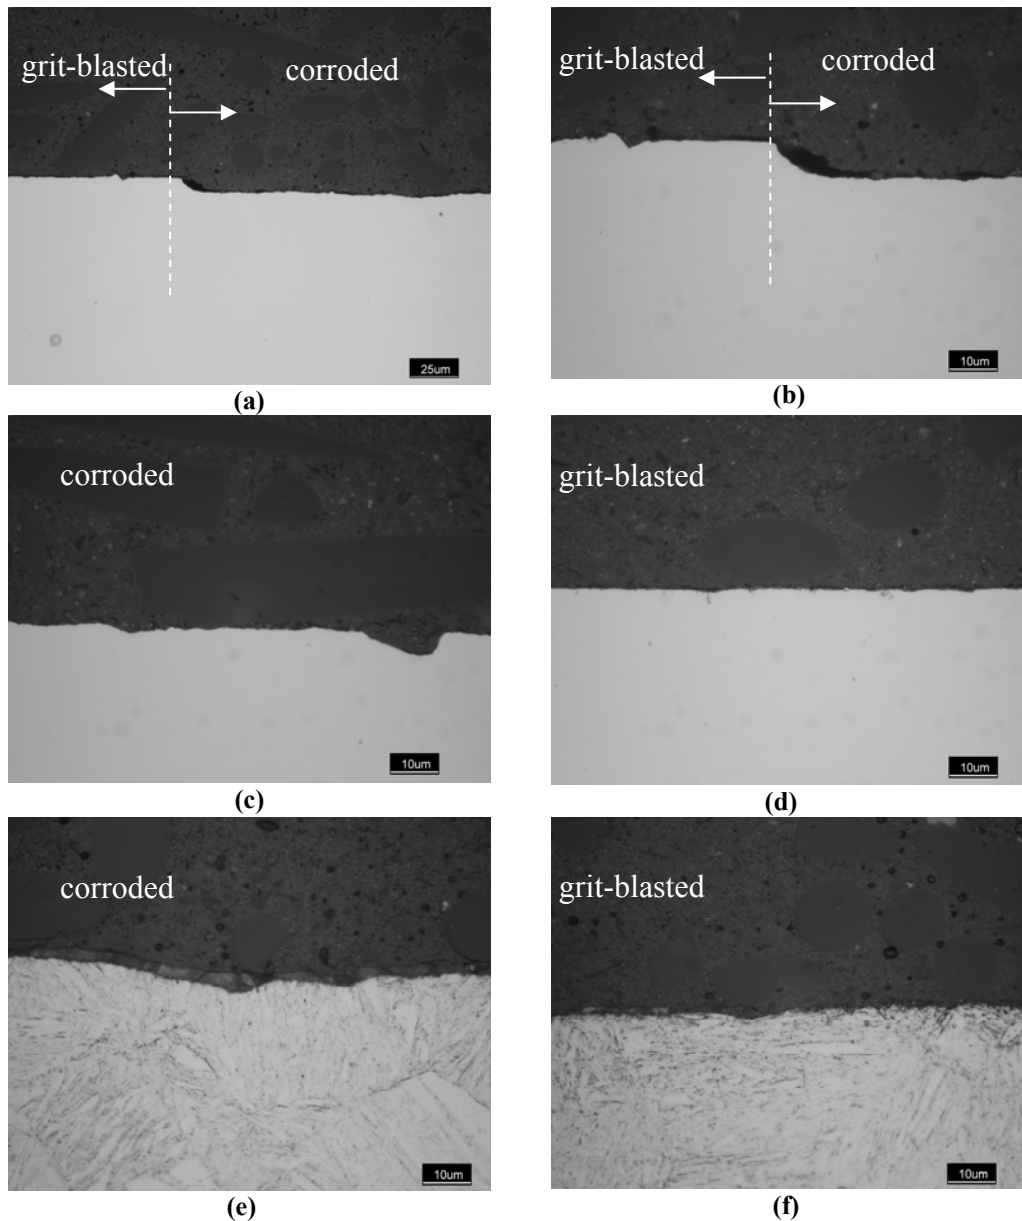
The last two images in Figure 4.2.1-26(e) and (f) are, again, of the corroded region and of the grit-blasted region (non-corroded region), respectively. In this case, the surfaces were etched with 2% Nital for several minutes in order to reveal the martensitic microstructure. Note that these images were not taken in the same locations as those in Figures 4.2.1-26(c) and (d). It can be observed from these images that the corrosion does not seem to preferentially ingress along grain boundaries. Instead, it has a general corrosion appearance. During optical inspection, it was also observed that the corrosion attack at the surface does follow laths in the microstructure. The ingress observed is very shallow and is limited to a depth just below the surface. This phenomenon is not evident in these figures due to the quality of the sample preparation and of the images.

Figure 4.2.1-26. Cross-Section Images of Test Wafer AF1410-6hr: (a) & (b) are micrographs of the transition region between the corroded and grit-blasted surfaces, (c) & (e) were taken in the corroded region, (d) & (f) were taken in the grit-blasted region. The images in (e) and (f) were taken after the cross-sections were etched in 2% Nital.

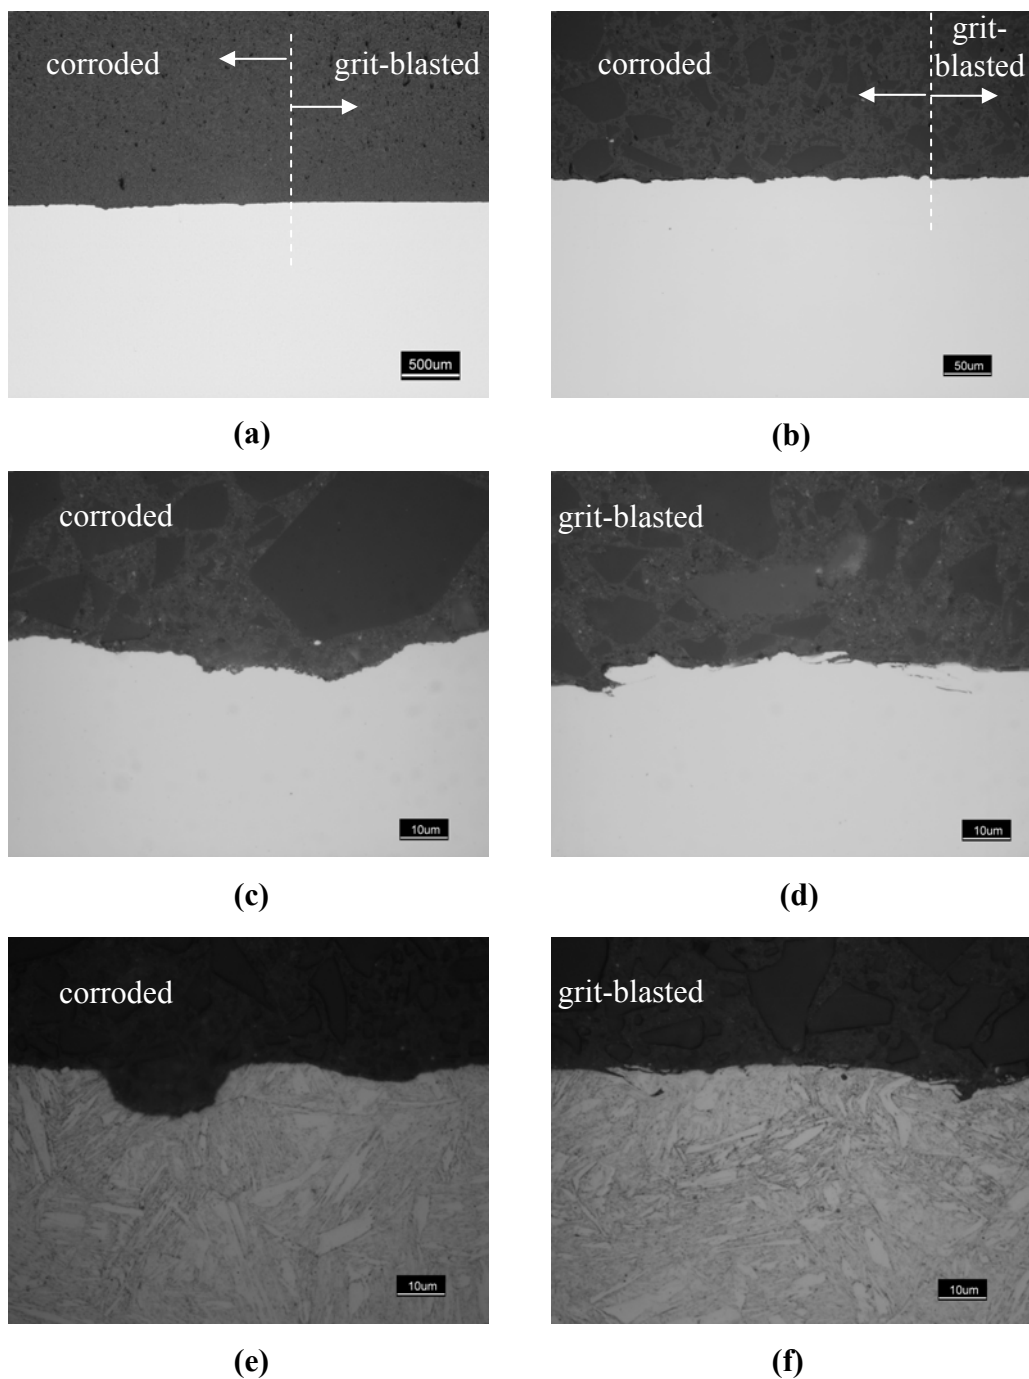
The last two images, Figure 4.2.1-28(e) and (f), are again of the corroded region and of the grit-blasted region (non-corroded region), respectively. In this case, the surfaces were etched with 2% Nital for several minutes in order to reveal the martensitic microstructure. Note that these images were not taken in the same locations as the images in Figures 4.2.1-28(c) and (d). It can be observed from these images that the corrosion does not seem to preferentially ingress along grain boundaries. Instead, it has a general corrosion appearance. During optical inspection, it was also observed that the corrosion attack at the surface does follow laths in the microstructure. The ingress observed is very shallow and is limited to a depth just below the surface. This phenomenon is not evident in these figures due to the quality of the sample preparation and of the images.

Figure 4.2.1-28. Cross-Section Images of Test Wafer AF1410-12hr: (a) & (b) are micrographs of the transition region between the corroded and grit-blasted surfaces, (c) & (e) were taken in the corroded region, (d) & (f) were taken in the grit-blasted region. The images in (e) and (f) were taken after the cross-sections were etched in 2% Nital.

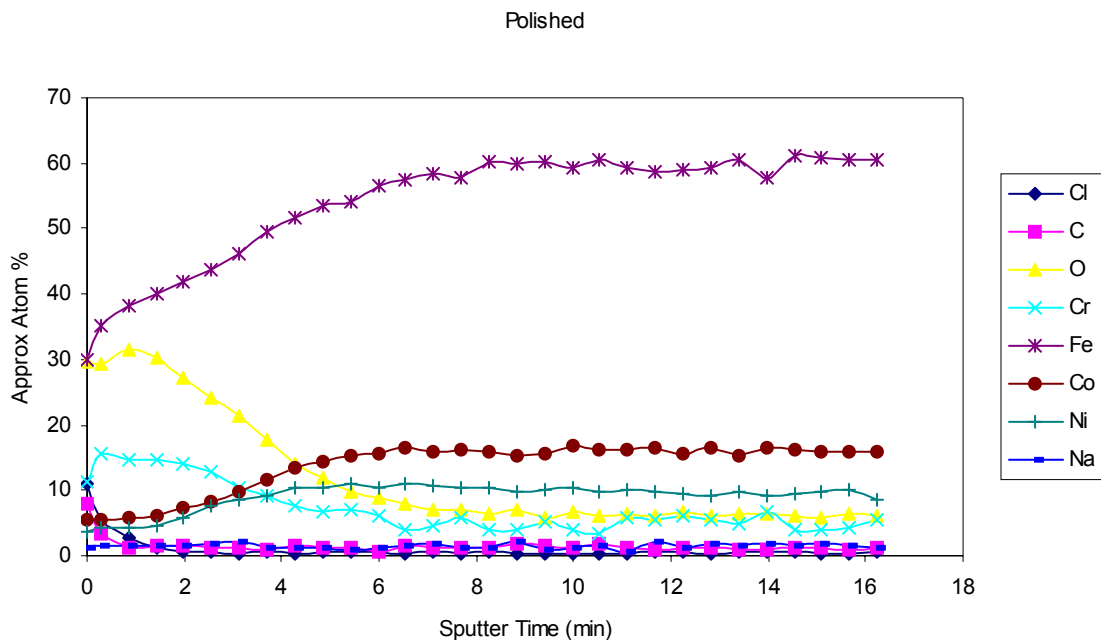
Figure 4.2.3-9. Auger Electron Spectroscopy Results from a Non-Corroded, Polished AF1410 Sample

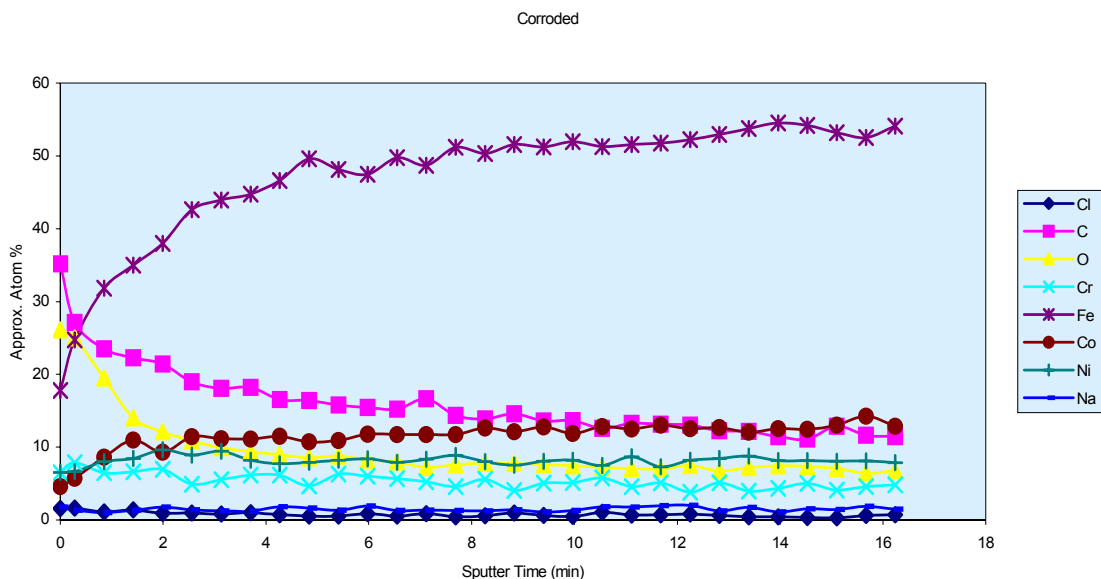
Figure 4.2.3-10. Auger Electron Spectroscopy of Corroded AF1410 Sample

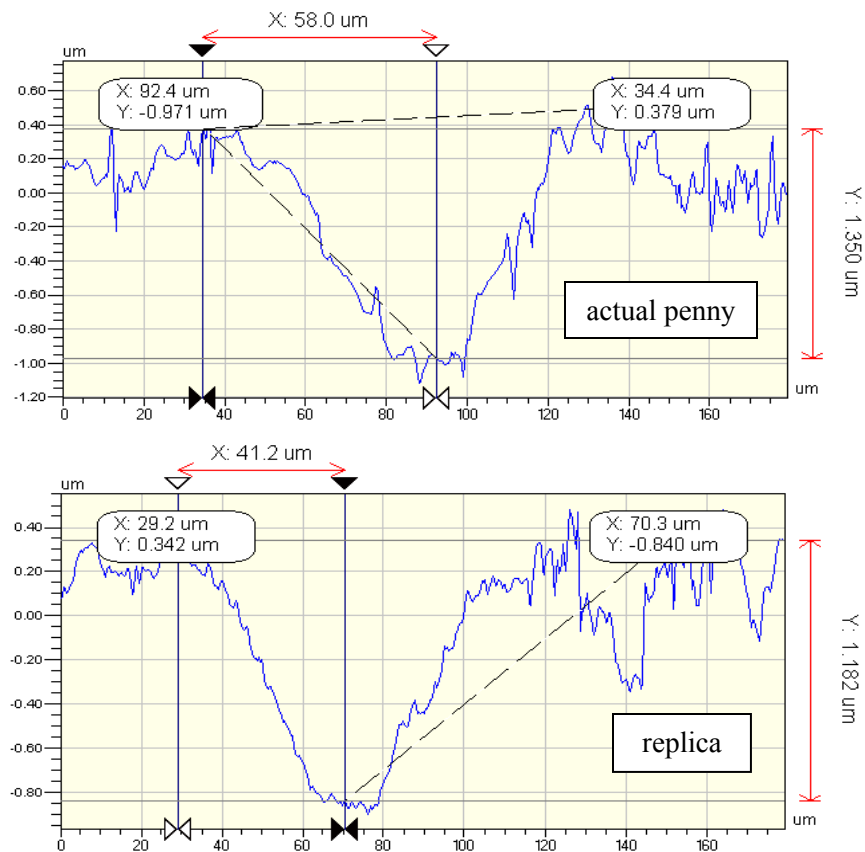
Figure 4.2.6-2. Profiles of Scratch on Penny Taken from White-Light Interference Microscopy Measurements on Actual Penny (Top) and a Replica (Bottom)

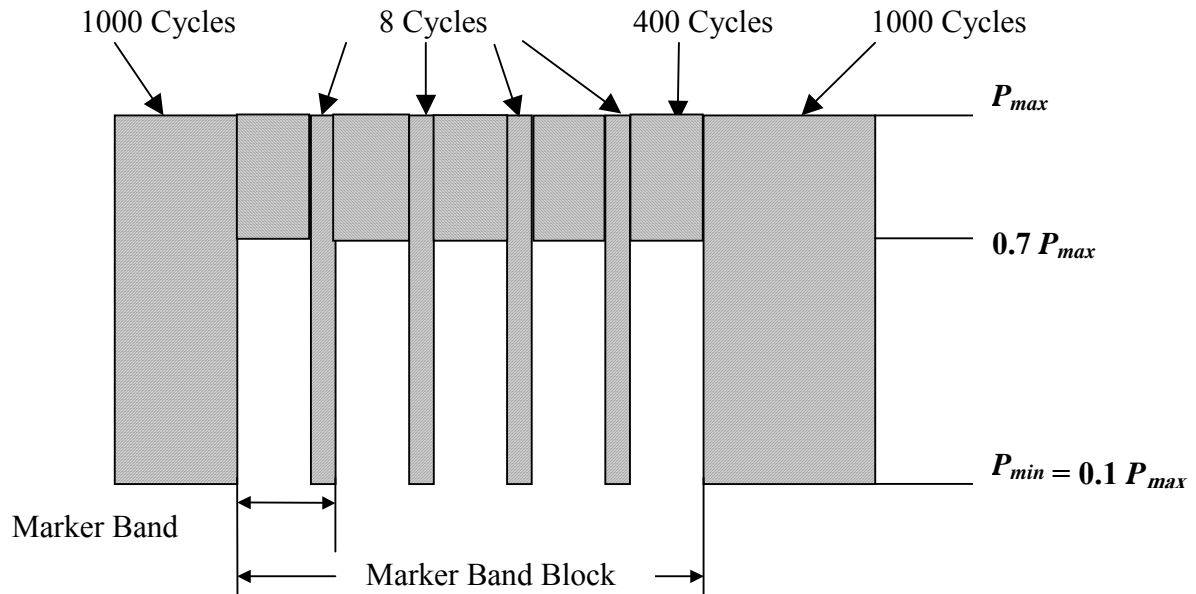
Figure 4.2.8-1. Four Marker Band Pattern

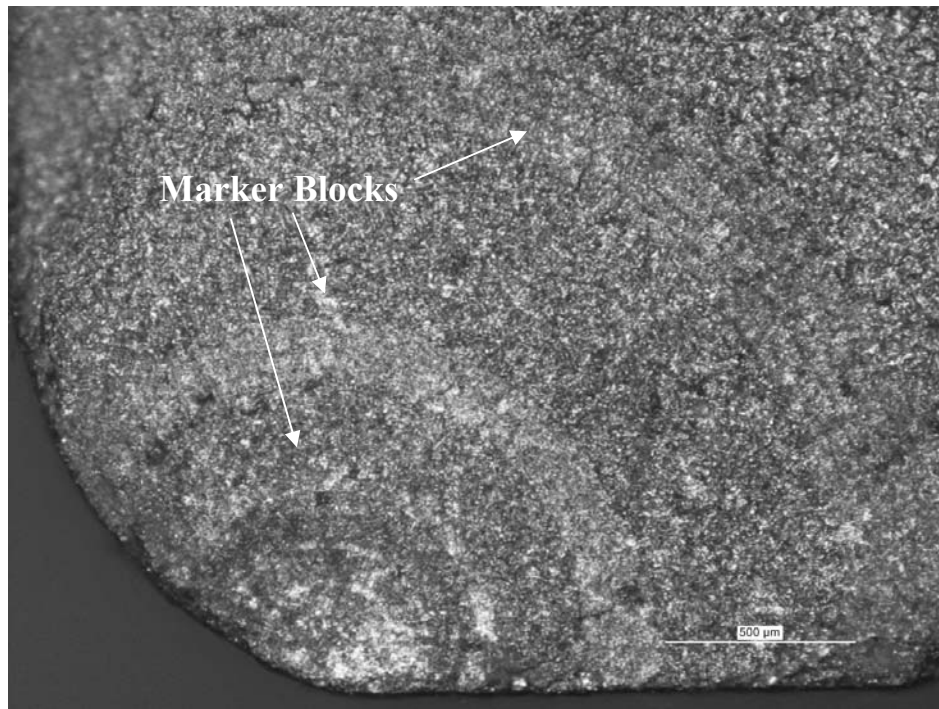
Figure 4.2.8-2. Fracture Surface of Critical Crack on Specimen #19

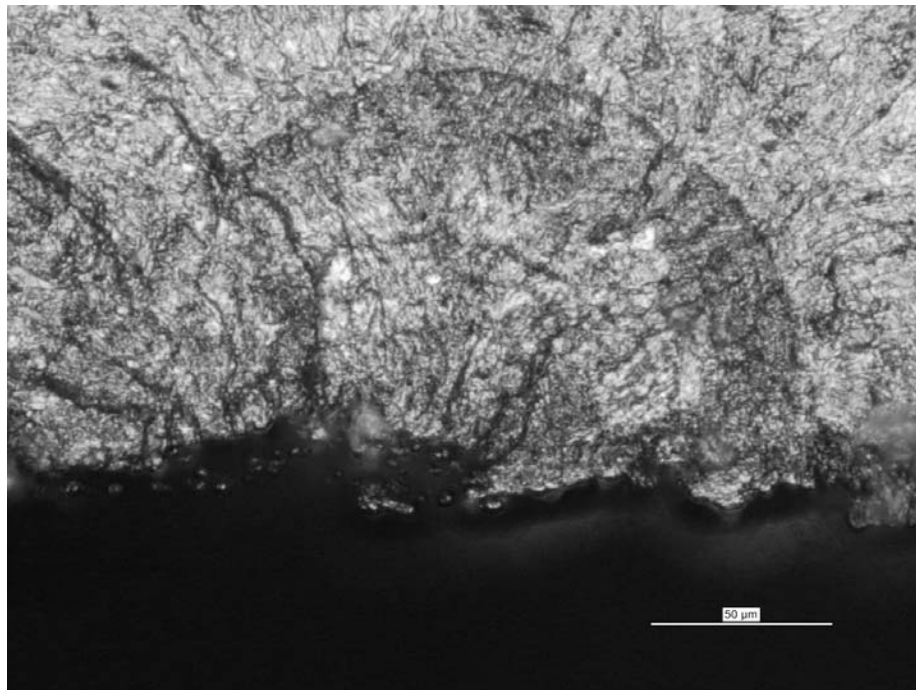
Figure 4.2.9-3. Critical Crack Origin on Specimen #61

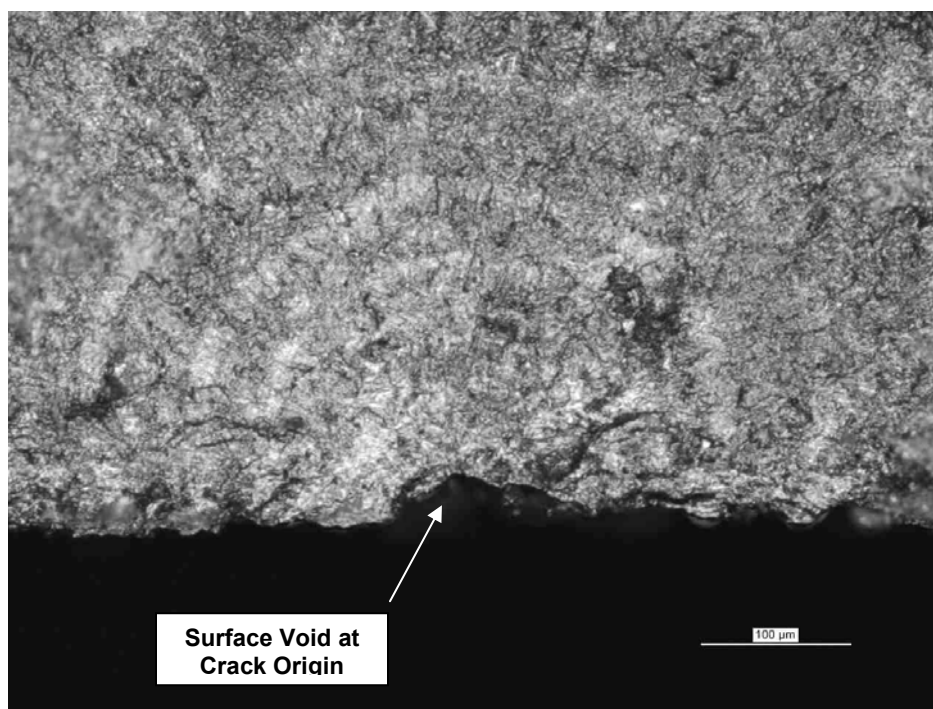
Figure 4.2.9-4. Critical Crack Origin on Specimen #29

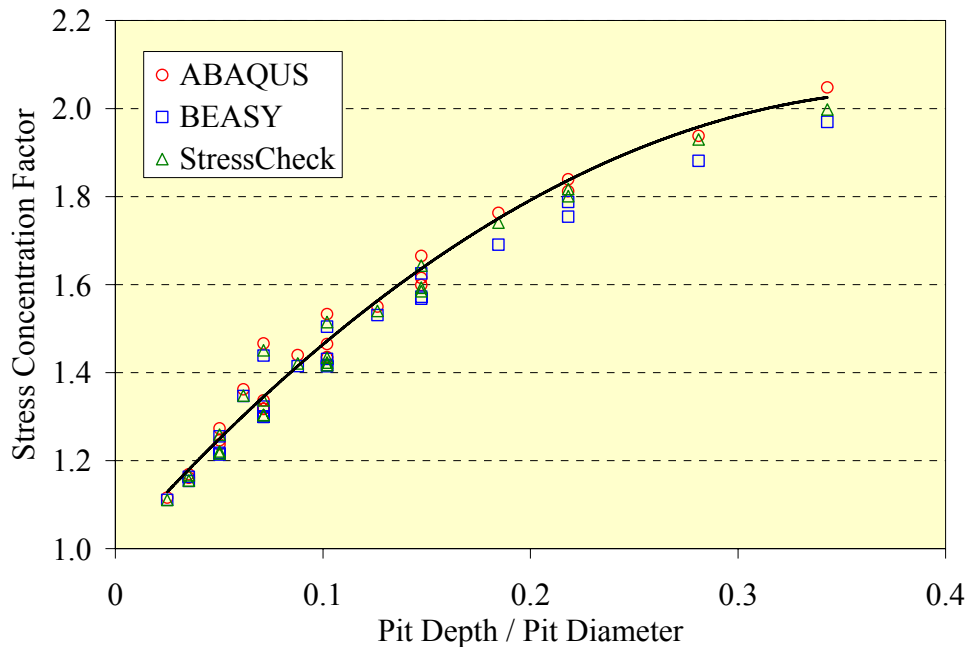
Figure 5.2.5-3. Normalized Analysis Results of Individual Spherical Pit Geometries (Case 5)

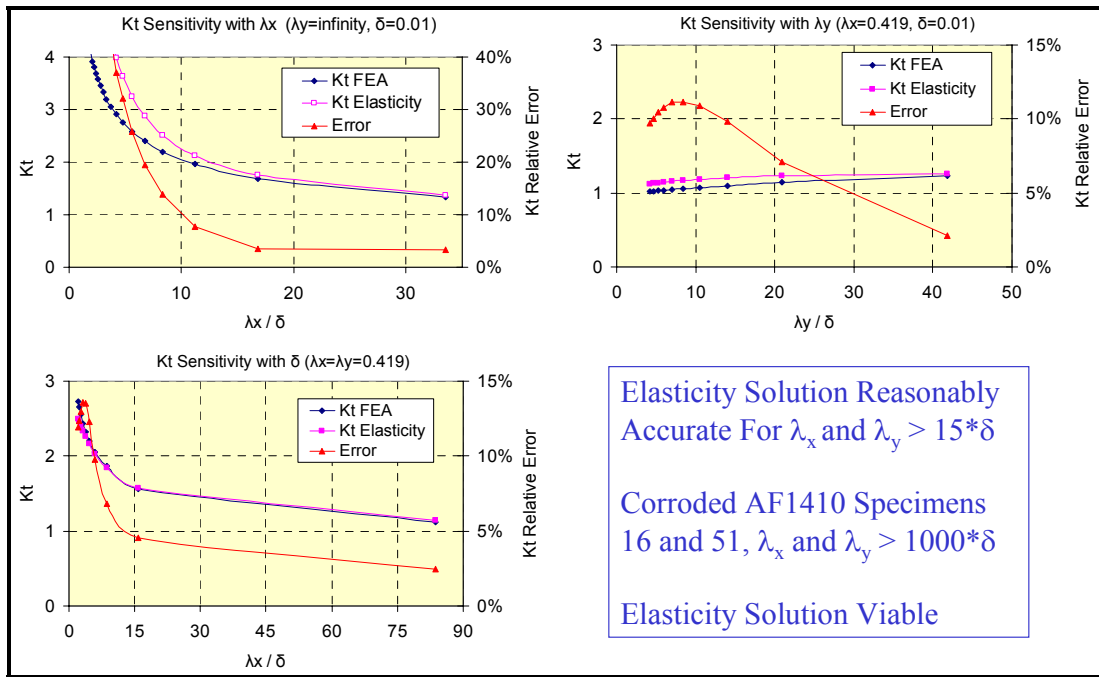
Figure 5.4-4. Accuracy of Individual Frequency Component Elasticity Solutions

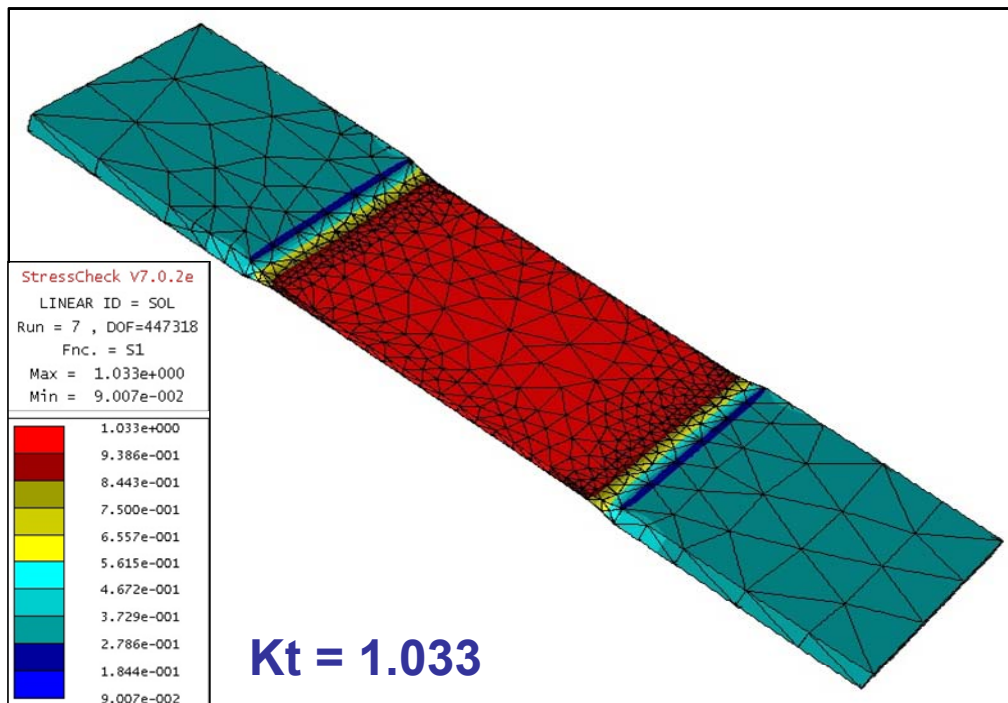
Figure 8. Pristine Case Dogbone Maximum K_t

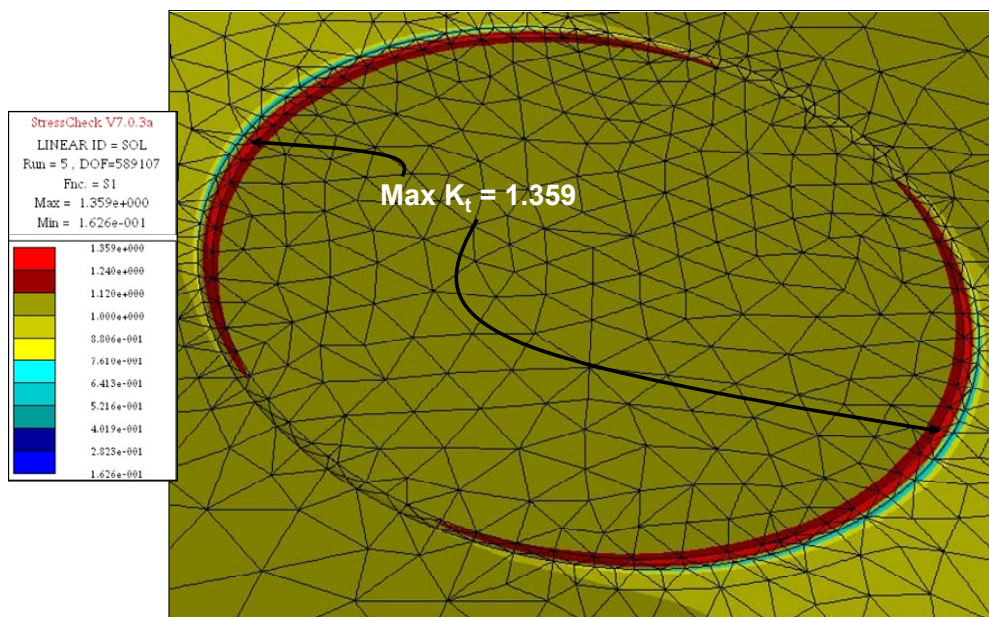
Figure 18. Disc-Shaped Surface Defect of $r_f=0.04''$
